76 - ERGONOMIC ANALYSIS OF PAINTING ACTIVITY ON A PUBLIC EDUCATIONAL BUILDING

FERNANDA APARECIDA HENNEBERG;
 NATHALIE CAVALCANTI MONTEIRO;
 ROSEMARA SANTOS DENIZ AMARILLA;
 KIRILL ALEKSEEV;

RODRIGO EDUARDO CATAI;
 Universidade Tecnológica Federal do Paraná (UTFPR)
 Curitiba - Paraná - Brazil
 fernandaa@utfpr.edu.br 1

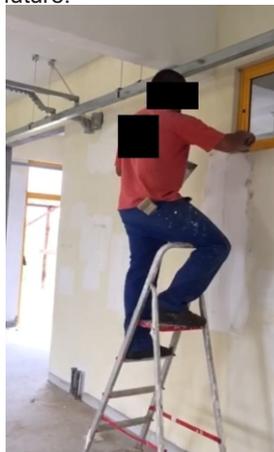
Figure 1 - Surface preparation

Figure 1 shows the plaster realization posture. In this task, the result obtained by RULA was 5 (five) points, indicating the need for an investigation and being introduced changes. Presenting similar result by OWAS tool, this posture falls under the category two (2), requiring corrections in the near future.

In the case of Figure 1, could be used one footrest for the legs stay well supported and balanced. This change would reduce the result of RULA at one (1) point, resulting in a less critical action level.

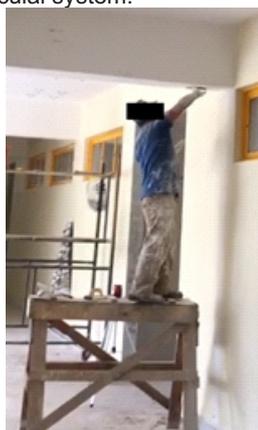
In the second posture of surface preparation, it has been identified activity movements and analyzed the posture shown in Figure 2. For this task, which precedes the painting, has been noted great demand of the arms, neck and trunk rotation. Thus, the scores obtained was seven (7) in RULA tool, which result indicates the need to introduce changes immediately (Figure 3). By the OWAS tool, it has not been identified corrective measures (Figure 4). This score difference it is probably due to the fact that OWAS does not devote much attention for upper limbs, however with RULA result is possible to detect the importance of improving this presented posture.

In the sanding task (Figure 2), changing the stand height would reduce the impact on the neck and arms. Also changing the type of footrest for enhanced stability and surface would reduce the need for torso rotation and allow legs and feet balance. This position needs frequent repositioning of the upper limbs and it is complicated the precise movements of the worker in this task execution. Therefore, with these changes, the score RULA could achieve four (4) points, resulting in a less critical level of action in order to eliminate overloading the muscular system.
